## RT809H Programmer Technical Upgrading Notification

NO:20170001

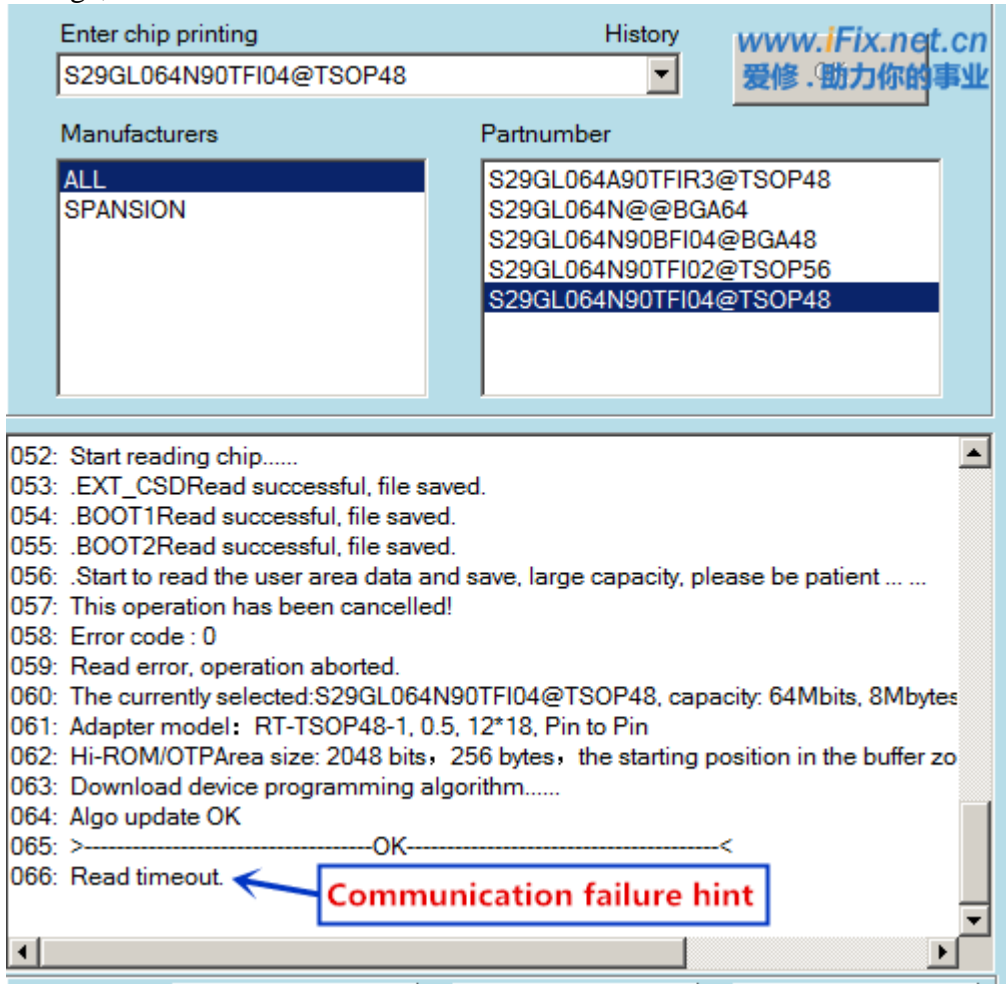
1.When self testing or reading and writing the 28/29 series NOR FLASH chip with VPP high voltage,communication fails.

- 1 : R26 Resistor Original parameter is 12K or 10K ; Modified parameter is 4.7K
- 2 : C18 Capacitor Original parameter is 106 ; Modified parameter is 476/10V
- 3 : C22 Capacitor Original parameter is 104 ; Modified parameter is 476/10V

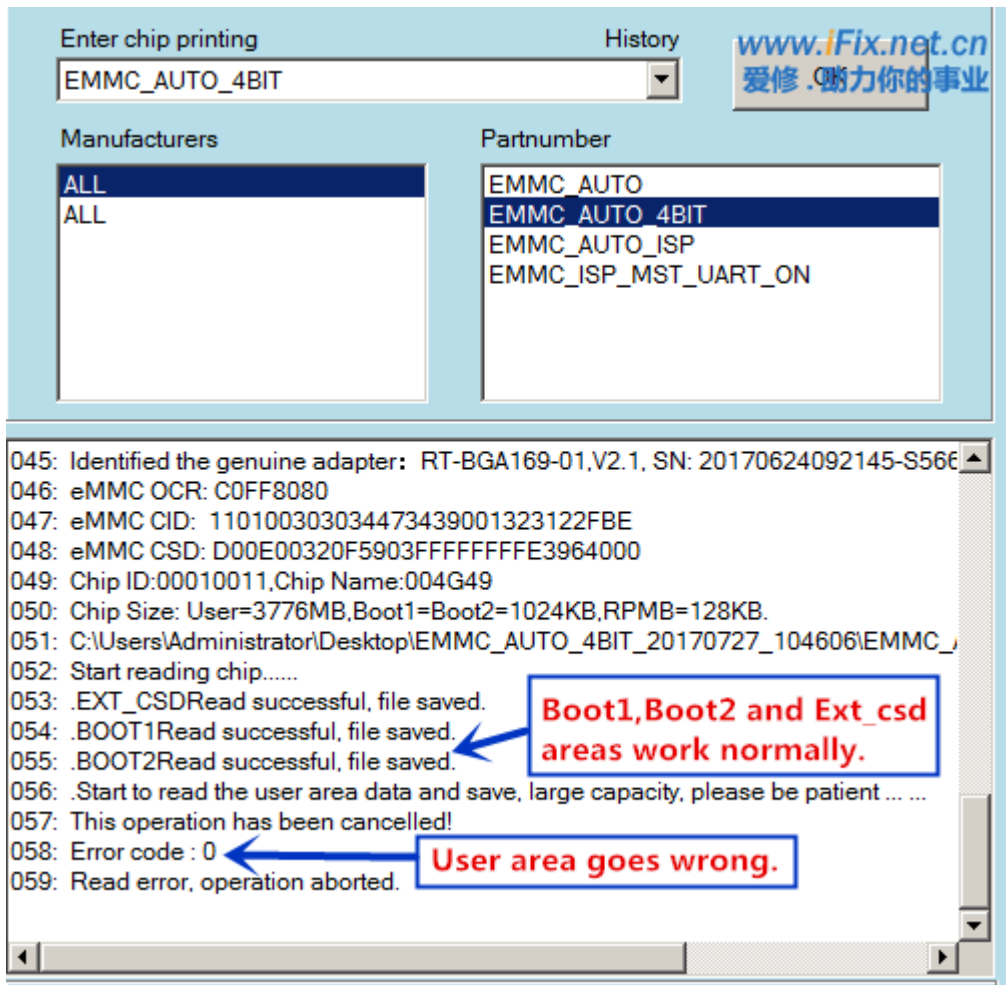
2.When reading EMMC off line,Boot1,Boot2 and Ext\_csd areas work normally but User area goes wrong.
